How to Avoid CPVC System Failure

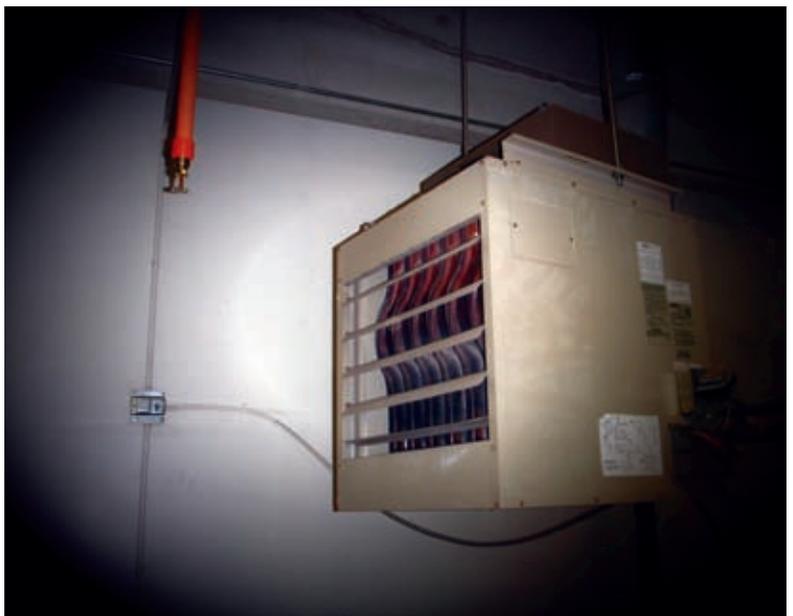
- Installation and gluing of joints occurred at ambient temperatures below the manufacturer's listed minimums.
- The several-hundred-foot lengths of main floor pipe had no method to account for thermal expansion.
- In some areas, pipe was installed too close to heat-producing devices (see Figure 1).
- Wall penetrations had insufficient clearances.

Figure 1 This installation demonstrates a CPVC pipe system and sprinkler in the direct path of a unit heater, which is a direct code violation that can lead to CPVC pipe fracture and burst.

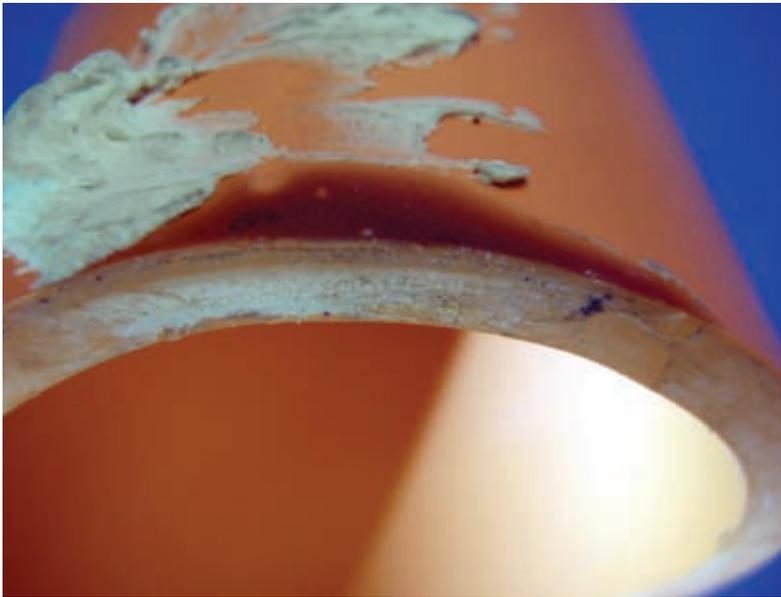
Figure 2 This failure was due to environmental stress cracking created by the application of a caulk with a hydrocarbon base.

Exterior ESC issues have been observed as well. While no evidence of ESC was observed, the pipe in the Denver case had been painted in conflict with the manufacturer's listing. CPVC pipe must not be coated with any unapproved material, or the listing, and thus the warranty, will be voided. Exposure to many hydrocarbons and pesticides also will result in ESC and may result in exterior crack formation (see Figure 2).

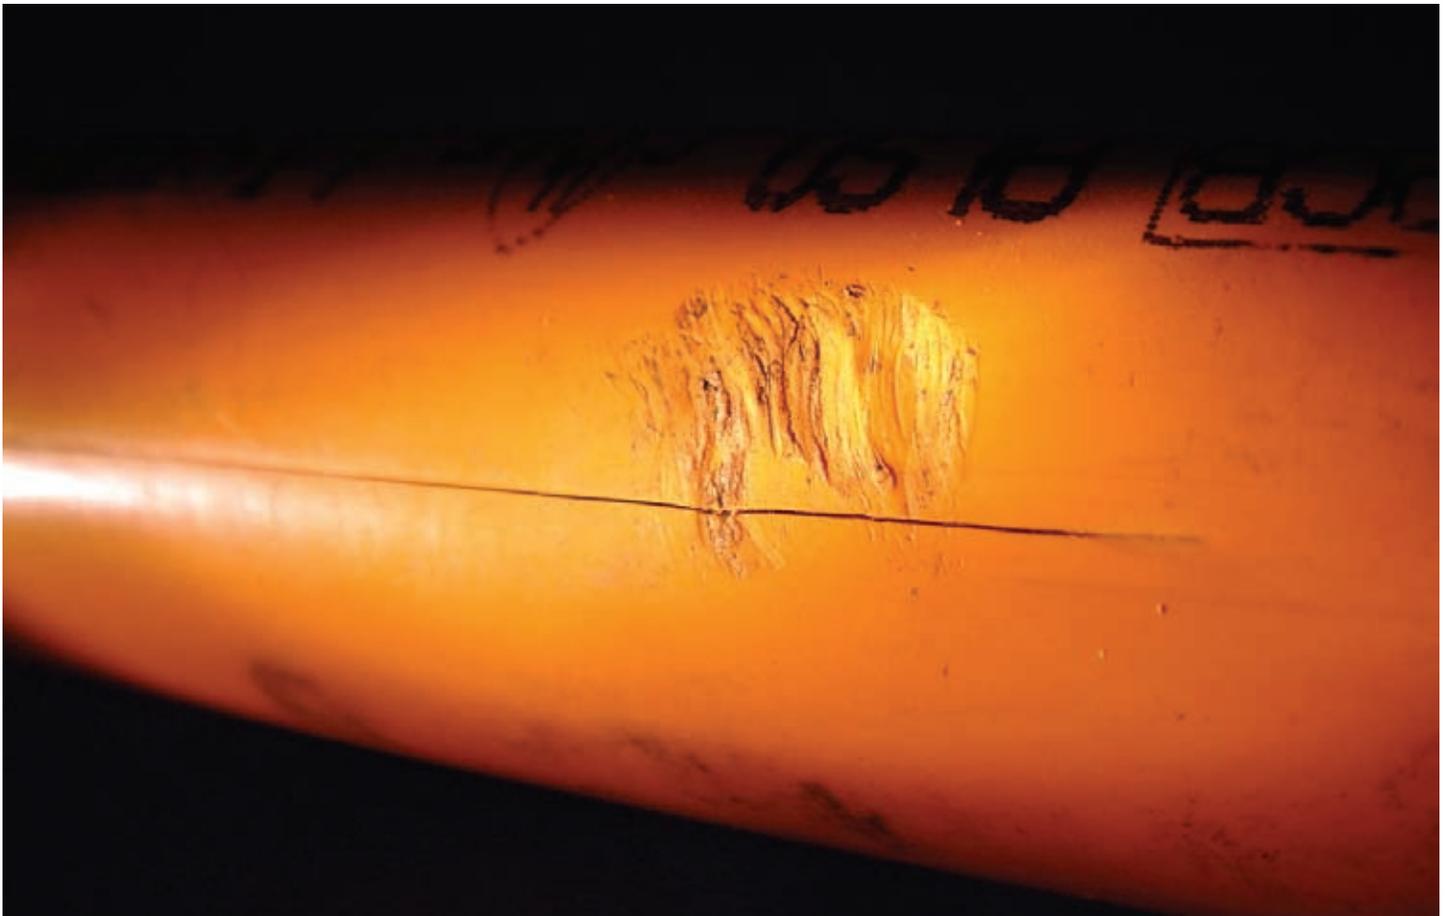
Figure 3 The longitudinal fracture was the result of a deep gouge in the pipe.

In most cases, the manufacturer's instructions identify and warn of these issues, but some designers, installers, and users don't read the manufacturer's manual or instructions. Scrapes, gouges, and impact will create a stress concentration that can result in rupture. Laboratory testing resulted in

illustrating a significant reduction in burst strength when the pipe was scratched with an awl (see Figure 3).

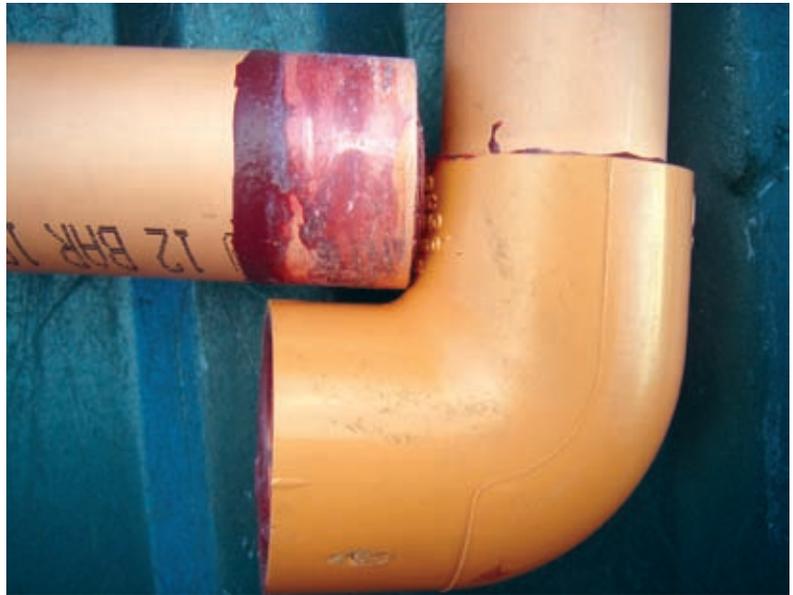
Use of a non-listed glue also has been observed. The joints do not bond completely, and the glue fractures, allowing the pipe to separate from the socket or fracture (see Figure 4).

Figure 4 This failure was the result of an improperly glued joint.
