Effects of Glycerin Antifreeze on CPVC

FROM PAGE 4 OF
THIS REPORT:

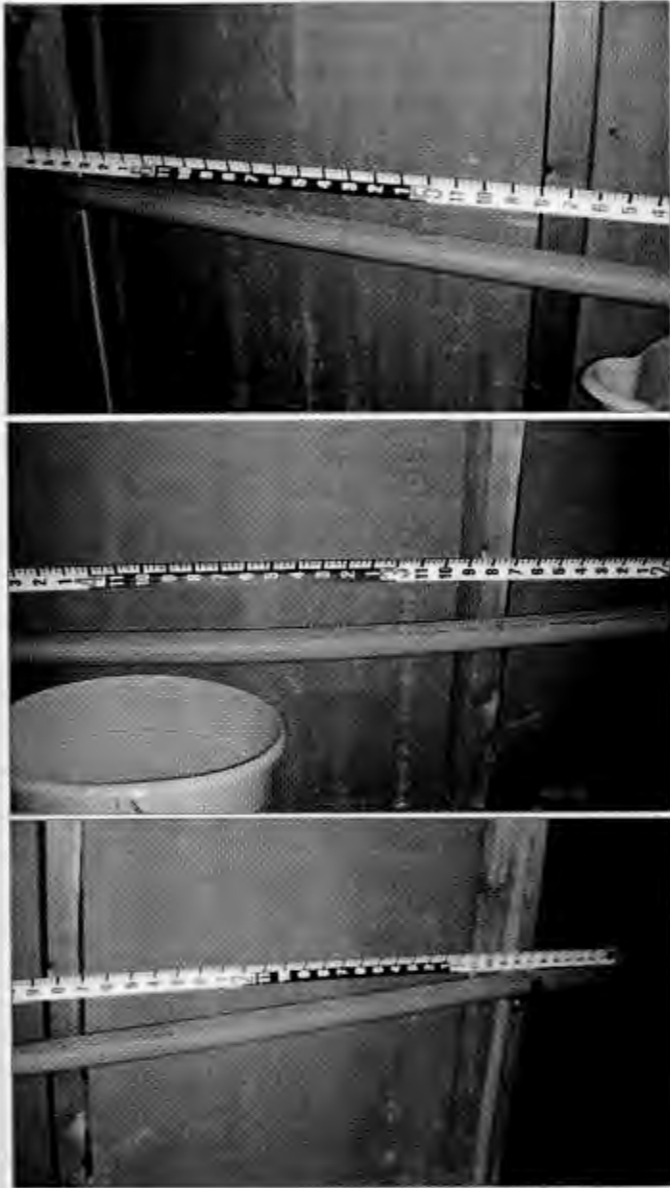
Figure 6 – Sagging of an installed CPVC pipe exposed to a mixture of water and bio-glycerin.

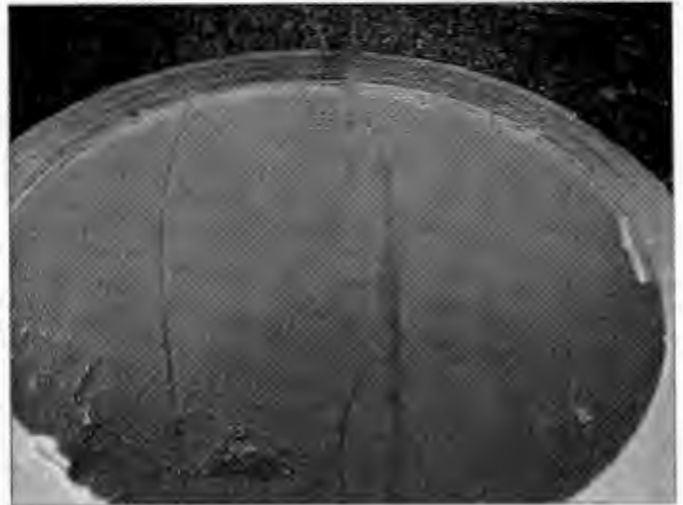
Figure 7 – Striations evident at the inside of a failed CPVC pipe exposed to a mixture of water and bio-glycerin.

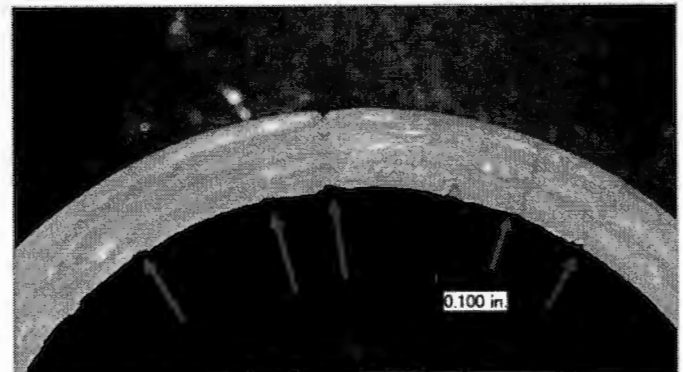
Figure 8 – Striations initiating at the inner diameter of the CPVC pipe exposed to a mixture of water and bio-glycerin.
